**Flood Control Project Maintenance  
Levee Inspections**  
**LMA District Cover Sheet**  
**Spring 2020 Levee Inspection Results**

**American River Flood Control District**

**Spring 2020 Levee Inspection Results**

Waterway			Bank	Unit Miles
Unit No. 01 Arcade Creek			Left	2.08
	Spring (March - May)	Summer (June - August)	(September - November) Fall	Winter (December - February)
Unit Maintenance Rating (Fall Only)				
Date of Inspection	3/25/2020 - 3/25/2020			
DWR Inspector	Luz Dial			
Accompanied By	Gilbert Gutierrez ARFCD

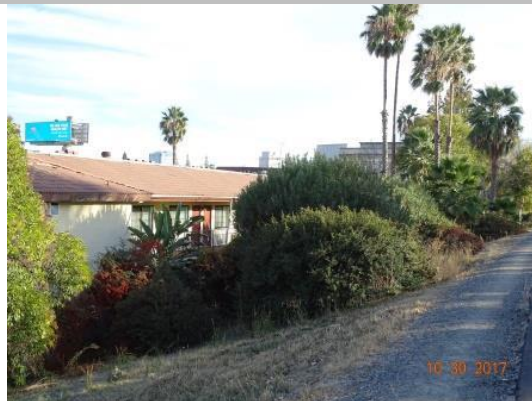
Photo 2 of 2 : SP\_2020\_NA0001\_56\_2\_20200302\_00002.jpg

View of the landscaping on the landside levee slope obstructing visibility and access. Fall 2017

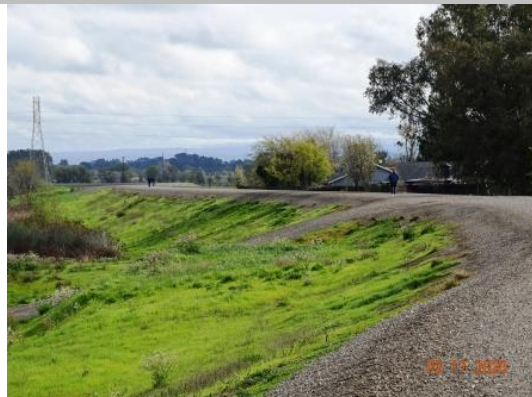
Photo 1 of 1 : SP\_2020\_NA0001\_57\_5\_20200319\_00011.jpg

LM Start	0.01	Rating **	A	Issue No.	5
LM End	1.30	Issue Type +	Ma	Location *	WS
Category	Earthen Levee			GPS Latitude/Longitude	
				Start	End
Item	Vegetation			38.657468 °	38.662317 °
				-121.474668 °	-121.452373 °
DWR ID	DWR_NA0001_06_s_2020_5				
Comment Code					
V1 : Control annual grass and weeds on the levee slopes and easements.					
Inspector Comment					
The waterside vegetation is well-maintained.

View of well-maintained waterside vegetation. Spring 2020

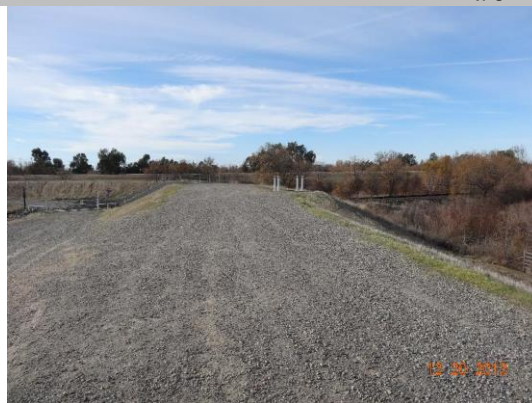
Photo 1 of 3 : UCIP\_SP\_2020\_26884\_49630.jpg

LM Start	0.02	Rating **	A/W	Issue No.	7
LM End	0.02	Issue Type +	Ma	Location *	
Category	Supplemental			GPS Latitude/Longitude	
				Start	End
Item	DWR UCIP LMA Responsibility			38.657400 °	38.657400 °
				-121.474455 °	-121.474455 °
DWR ID	24092				
Comment Code					
Inspector Comment					
DS_ID:24092					
FS_ID:26884					
EP_NO: N/A					
Repair Type: No Action Needed					
Crossing Status: Found					
UCIP Comments:					
FIELD_STRUCT_DESC: 24-inch corrugated metal (CM) drainage pipe through the levee, 22.7 feet below the crown. Two CM cutoff walls around pipe. Slide gate in 30-inch CM riser and flap gate at located on the waterside (WS) end. Concrete headwalls on both ends, WS and landside (LS). [Additional Reference(s): DWR Levee Log, 2002. USACE Sacramento O&M Manual Unit 118 Part 2, August 1959, Drawing No. 1-4-392 of Exhibit B, (Station 396+65)].					
FS Date: 12/20/2013

View of levee crown at crossing.

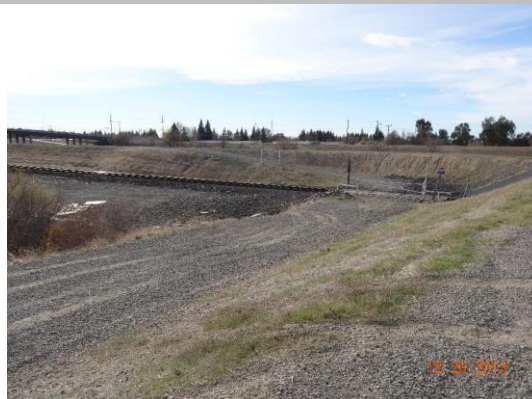
Photo 2 of 3 : UCIP\_SP\_2020\_26884\_49629.jpg

View of landward side.

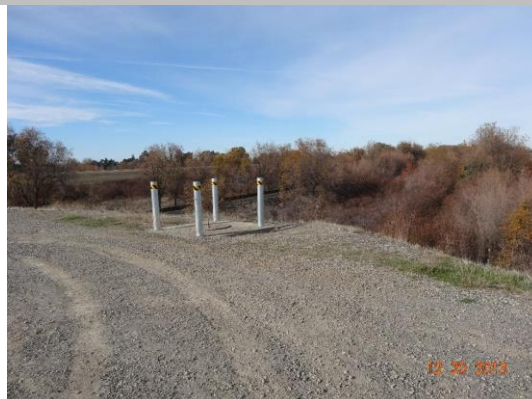
Photo 3 of 3 : UCIP\_SP\_2020\_26884\_49628.jpg

Concrete vault protected by posts located on waterward shoulder.

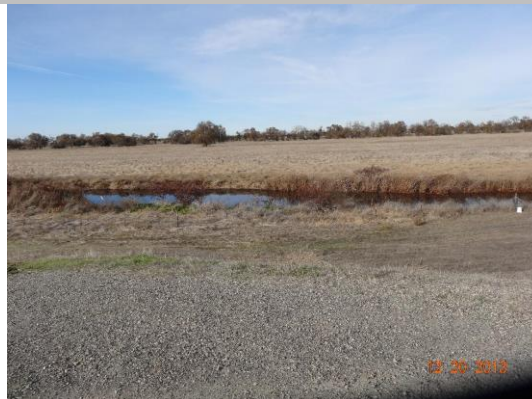
Photo 1 of 3 : UCIP\_SP\_2020\_30706\_56559.jpg

DS\_ID:24812  
FS\_ID:30706  
EP\_NO: N/A  
Repair Type: Non-Urgent  
Crossing Status: Indicator Found  
UCIP Comments: 08/16/2017 DWR Deferred Maintenance Project (DMP), Vince Rodriguez, forwarded email received from Tim Kerr, General Manager of American River Flood Control District (ARFCD) with file "DWR Eligible Pipes Found in ARFCD" from ARFCD that shows the ownership and location of the pipes Tim Kerr investigated. Owner of this crossing is identified as the City of Sacramento, ARFCD Staff Notes indicate landside DI near Pinedale. (DWR UCIP - O. Magana)  
12/20/2013 Unable to confirm if line goes through levee or along landward slope. No permit found. (DWR UCIP - O. Magana)  
FIELD\_STRUCT\_DESC: Storm drain manhole located on landside (LS). (no permit has been identified authorizing this structure, structure is owned by the City of Sacramento)  
FS Date: 12/20/2013

View of waterward side.

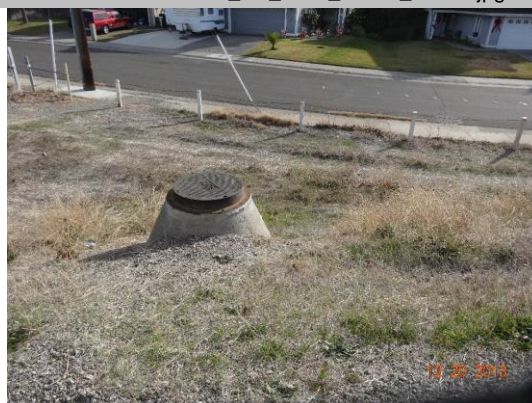
Photo 2 of 3 : UCIP\_SP\_2020\_30706\_56558.jpg

Manhole located on landward slope.

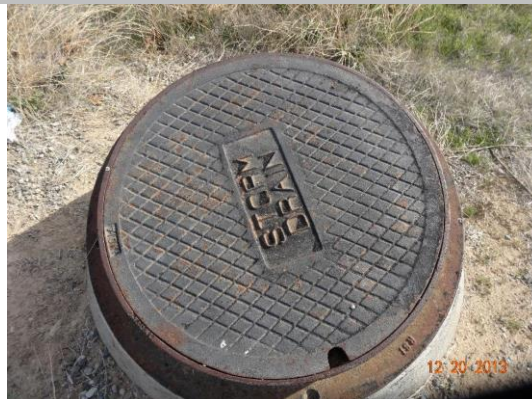
Photo 3 of 3 : UCIP\_SP\_2020\_30706\_56557.jpg

Manhole located on landward side identified as storm drain. Unable to determine if drain crosses levee.

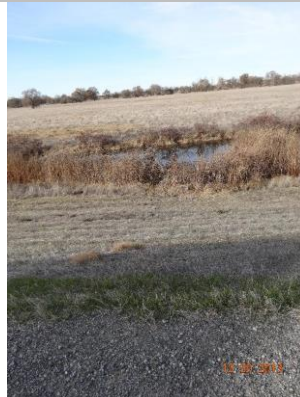
Photo 1 of 3 : UCIP\_SP\_2020\_29223\_54002.jpg

Comment Code						
Inspector Comment						
DS_ID:24354 FS_ID:29223 EP_NO: N/A Repair Type: Non-Urgent Crossing Status: Indicator Found UCIP Comments: 08/16/2017 DWR Deferred Maintenance Project (DMP), Vince Rodriguez, forwarded email received from Tim Kerr, General Manager of American River Flood Control District (ARFCD) with file "DWR Eligible Pipes Found in ARFCD" from ARFCD that shows the ownership and location of the pipes Tim Kerr investigated. Owner of this crossing was not identified, ARFCD Staff Notes indicate old pipe between Kelton and Sully (not found). (DWR UCIP - O. Magana) 12/20/2013 Unable to find CM riser and flap gate on waterward end--need to contact owner to determine status of crossing. Manhole found on landward side however unable to determine if manhole is part of this crossing. (DWR UCIP - O. Magana) FIELD_STRUCT_DESC: 24-inch corrugated metal drainage pipe through the levee, 12.5 feet below the crown. Two corrugated metal cutoff walls around pipe. Slide gate in corrugated metal riser and flap gate on waterside (WS) end. Concrete headwalls on both ends, WS and landside (LS). (no permit has been identified authorizing this structure - no owner has been identified) [Additional Reference(s): USACE Sacramento O&M Manual Unit 118 Part 2, August 1959, Drawing No. 1-4-392 of Exhibit B, (Station 440+50)]. FS Date: 12/20/2013

View of waterward side--no evidence of crossing.

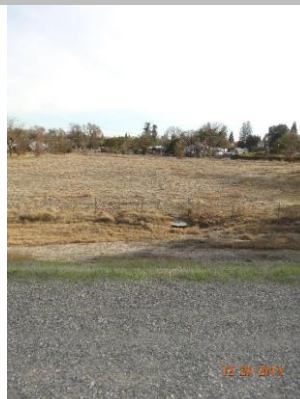
Photo 2 of 3 : UCIP\_SP\_2020\_29223\_54001.jpg

View of landward side--manhole on landward toe.

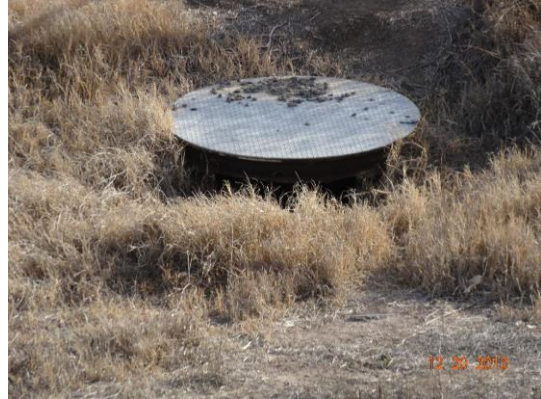
Photo 3 of 3 : UCIP\_SP\_2020\_29223\_54000.jpg

Manhole visible on landward toe.

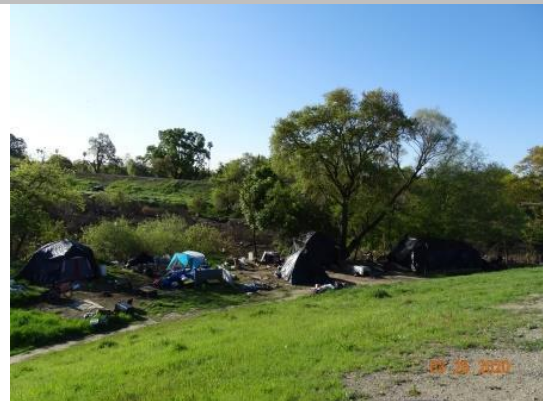
Photo 1 of 2 : SP\_2020\_NA0001\_58\_54\_20200326\_00066.jpg

LM Start	0.38	Rating **	M	Issue No.	54
LM End	0.54	Issue Type +	En	Location *	WS
Category	Earthen Levee			GPS Latitude/Longitude	
				Start	End
Item	Encroachments			38.623363 °	38.624575 °
				-121.462005 °	-121.459660 °
DWR ID	DWR_NA0001_07_s_2020_54				
Comment Code					
DE : Debris					
Inspector Comment					
Camps reside within 20' of the waterside toe.

View of camps located within 20' of the waterside toe. Spring 2020

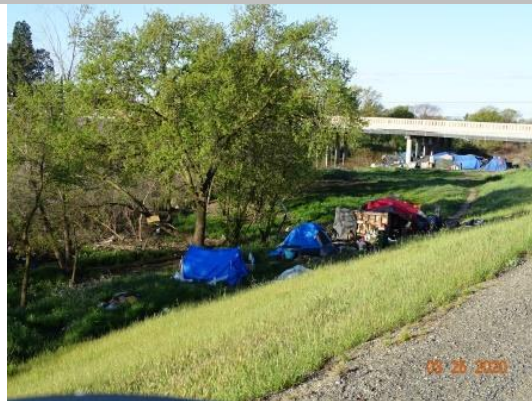
Photo 1 of 3 : SP\_2020\_NA0001\_58\_49\_20200326\_00061.jpg

LM Start	0.70	Rating **	M	Issue No.	49
LM End	0.70	Issue Type +	En	Location *	WS
Category	Earthen Levee			GPS Latitude/Longitude	
				Start	End
Item	Encroachments			38.624895 °	38.624895 °
				-121.457228 °	-121.457228 °
DWR ID	DWR_NA0001_07_s_2020_49				
Comment Code					
DE : Debris					
Inspector Comment					
Campers reside at the levee toe and underneath the Norwood Avenue bridge.

View of camps along the waterside toe. Spring 2020

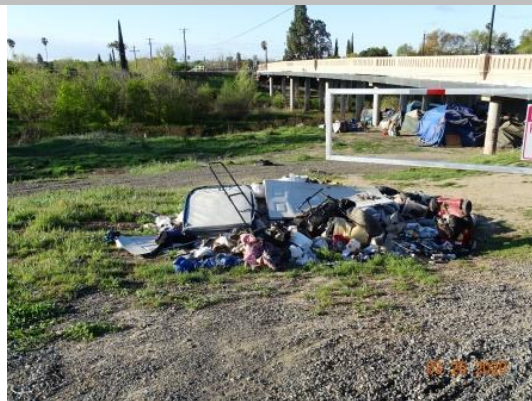
Photo 2 of 3 : SP\_2020\_NA0001\_58\_49\_20200326\_00062.jpg

View of debris on the waterside slope. Spring 2020

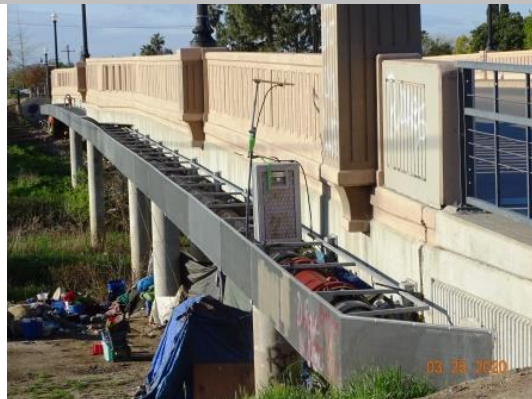
Photo 3 of 3 : SP\_2020\_NA0001\_58\_49\_20200326\_00065.jpg

View of tents tethered to the bridge piping and an antenna rigged to the bridge. Spring 2020

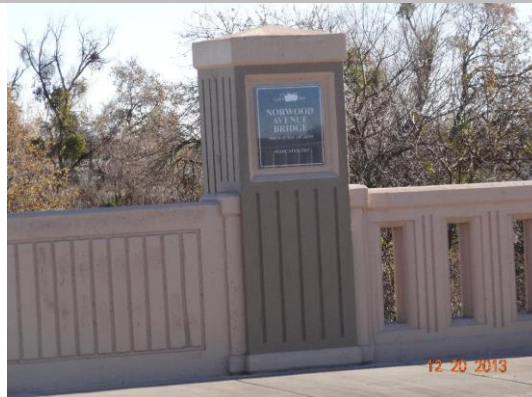
Photo 1 of 3 : UCIP\_SP\_2020\_53489\_54061.jpg

Comment Code					
Inspector Comment					
DS_ID:24363 FS_ID:53489 EP_NO: 18641-1 Repair Type: Non-Urgent Crossing Status: Found UCIP Comments: 07/18/2018 Everything appears to be the same as last time. No markers have been placed. This gas line is supposed to be raised to the 200-year water surface elevation. PG&E records for this distribution main indicate that there were no leaks found on the 06/2017 leak survey and the pipeline is operating correctly according to the 12/2016 CP inspection. Crossing is downgraded to "Non-Urgent" until the gas line is raised to the 200-year level. (A. McDonald - DWR UCIP)08/11/2016 Markers still missing. LMA representatives, Tim Kerr and Richard Marck, provided permit for PG&E line to be raised to 200-year water surface elevation. Pipe will be raised on both the right and left banks. Depth below the crown will need to be updated once construction is completed. (DWR UCIP - omagana)12/19/2013 Missing gas line markers -- need to contact owner to determine status. (DWR UCIP - omagana) FIELD_STRUCT_DESC: 4-inch steel natural gas pipeline through the levee, 2 feet below the crown. Corrugated metal (CM) cutoff wall around pipe at the center of the levee. Pipeline is protected by a cage along the side of the bridge. 4-inch gate valve will be installed on the LS approximately 355 feet from levee crown (near Fairbanks Avenue and Norwood Avenue). In case of an emergency related to this pipeline, PG&E has identified the following contacts: PG&E's local pipeline engineer, Mike Aronoff at 916-307-9472 (cell), and Gas Control (north) at 800-442-4743. For non-emergency issues, please contact the local PG&E Gas Pipeline Operations and Maintenance (GPOM) supervisors for the Sacramento region, David Wade at 209-639-1039 (cell), or Ron Hicks at 916-396-9038 (cell). (4-inch pipe installed under Permit No. 3417, 1961 - Pacific Gas and Electric Company [PG&E]; 4-inch pipe removed and replaced under Permit 18641, 2011 - PG&E; 4-inch pipe through levee (both right and left bank) raised above the 200-year water surface elevation under Permit No. 18641-1, 2016 - PG&E) [Additional Reference(s): DWR Levee Log, 2002] FS Date: 7/18/2018

Norwood Avenue Bridge

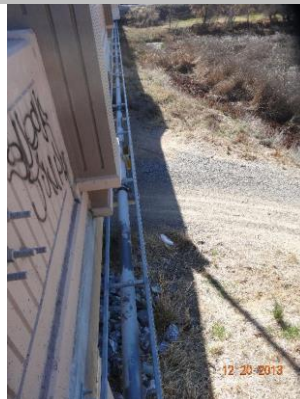
Photo 2 of 3 : UCIP\_SP\_2020\_53489\_54062.jpg

View of pipe attached to bridge.

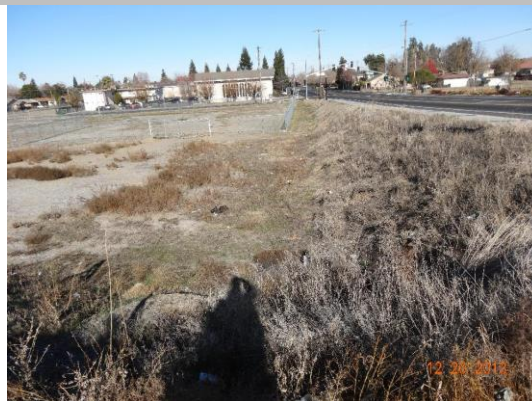
Photo 3 of 3 : UCIP\_SP\_2020\_53489\_54060.jpg

View of LS.

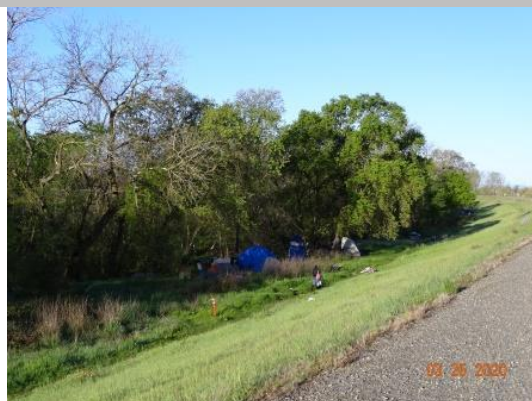
Photo 1 of 1 : SP\_2020\_NA0001\_58\_47\_20200326\_00060.jpg

LM Start	0.93	Rating **	M	Issue No.	47
LM End	1.07	Issue Type +	En	Location *	WS
Category	Earthen Levee			GPS Latitude/Longitude	
				Start	End
Item	Encroachments			38.625738 °	38.625888 °
				-121.453232 °	-121.450593 °
DWR ID	DWR_NA0001_07_s_2020_47				
Comment Code					
DE : Debris					
Inspector Comment					
Campers reside within 20' of the waterside toe.

View of camps located within 20' of the waterside toe. Spring 2020

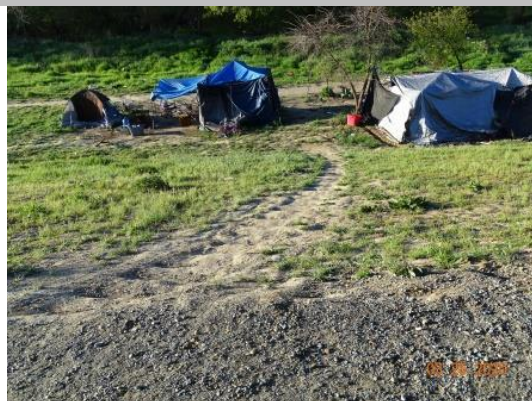
Photo 1 of 1 : SP\_2020\_NA0001\_58\_46\_20200326\_00059.jpg

LM Start	1.15	Rating **	M	Issue No.	46
LM End	1.15	Issue Type +	Ma	Location *	WS
Category	Earthen Levee			GPS Latitude/Longitude	
				Start	End
Item	Slope Stability			38.625773 °	38.625773 °
				-121.449115 °	-121.449115 °
DWR ID	DWR_NA0001_07_s_2020_46				
Comment Code					
S2 : Repair the levee slope damaged by foot traffic and prevent access where possible.					
Inspector Comment					
Steps are dug into the waterside slope.

View of steps dug into the waterside slope. Spring 2020

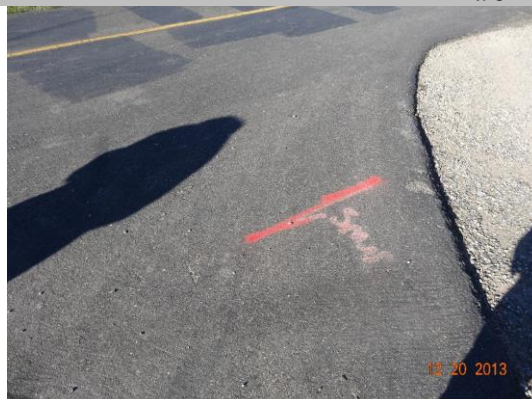
Photo 1 of 3 : UCIP\_SP\_2020\_40803\_48512.jpg

Comment Code						
Inspector Comment						
DS_ID:24447 FS_ID:40803 EP_NO: 16466 Repair Type: Non-Urgent Crossing Status: Found UCIP Comments: 06/14/2017 This crossing is scheduled to be cut and replaced as part of Sacramento Area Flood Control (SAFCA) North Area Streams (NAS) Levee Improvement Project: City of Sacramento Utility Permit Modifications Along Arcade Creek Levees. Unable to confirm when pipe will be replaced. Need to coordinate with owner and DWR FPIIB Inspector to determine when project is expected to start. (DWR UCIP - O. Magana). 12/20/2013 Need to contact owner to determine if crossings are at this location are associated with Permit number 16466--unable to confirm crossings. (DWR UCIP - O. Magana) FIELD_STRUCT_DESC: Two 6-inch and one 2-inch concrete encased steel utility conduits through the levee, all approximately 2 feet below the crown. Manhole located on the levee crown. (two 6-inch pipes and one 2-inch pipe authorized under Permit No. 16466, 1995 - Sacramento Municipal Utility District [SMUD]; modifications to existing crossings, cut and replace existing two 6-inch pipes and one 2-inch pipe, work authorized under Permit No. 16466, 2016 - SMUD) FS Date: 12/20/2013

Underground Service Alert (USA) marking present on pavement however, unable to verify crossings.

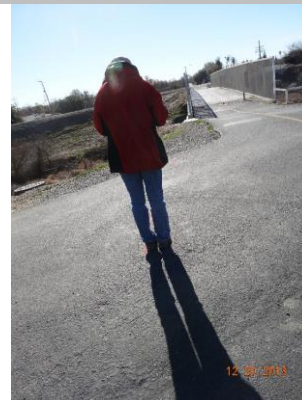
Photo 2 of 3 : UCIP\_SP\_2020\_40803\_48511.jpg

View of levee crown and estimate where crossings cross levee.

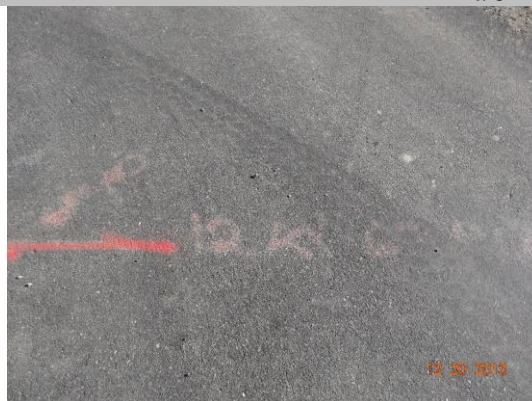
Photo 3 of 3 : UCIP\_SP\_2020\_40803\_48510.jpg

Underground Service Alert (USA) faint utility markers visible on levee crown.

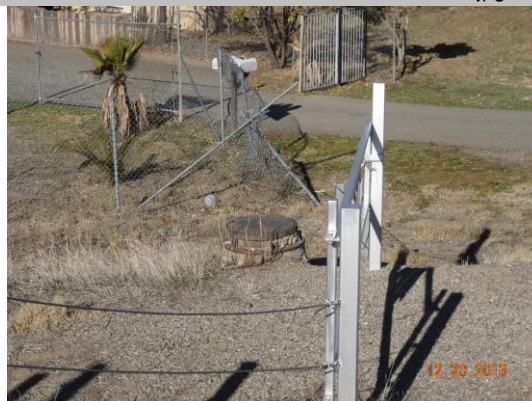
Photo 1 of 1 : UCIP\_SP\_2020\_29275\_54199.jpg

DS\_ID:24553  
 FS\_ID:29275  
 EP\_NO: N/A  
 Repair Type: Non-Urgent  
 Crossing Status: Found  
 UCIP Comments: Only manhole present--need to coordinate with owner to determine if crossing is still present and whether manhole corresponds to this crossing.  
 FIELD\_STRUCT\_DESC: 8-inch (not 10-inch as indicated in desk study) sewer pipe through the levee, 7.5 feet below the crown. Floodgates within the levee across the channel, installed under Permit No. 14480 (1986) by the City of Sacramento, Department of Public Works.  
 [Additional Reference(s): DWR Levee Log, 2002]  
 FS Date: 12/20/2013

Manhole visible on landward side.

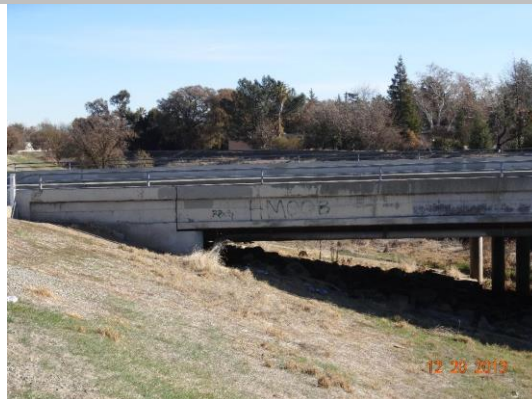
Photo 1 of 3 : UCIP\_SP\_2020\_53491\_75853.jpg

DS\_ID:24443  
FS\_ID:53491  
EP\_NO: 15152-1  
Repair Type: Non-Urgent  
Crossing Status: Found  
UCIP Comments: 07/18/2018 This pipeline was abandoned. It was cut and capped at the north end of the Rio Linda Blvd bridge. The section of pipe that goes under the levee is open on the WS end. This gas line is supposed to be raised to the 200-year water surface elevation. PG&E records for this distribution main indicate that there were no leaks found on the 07/2017 leak survey and the pipeline is operating correctly according to the 12/2016 CP inspection. Crossing downgraded to "Non-Urgent" pending documentation that this gas line has been abandoned properly. (A. McDonald - DWR UCIP)8/11/2016 Markers still missing. Will need to update depth below crown once construction is completed. (DWR UCIP - omagana)12/20/2013 Unable to confirm if crossing is the same one authorized through permit. (DWR UCIP - omagana) FIELD\_STRUCT\_DESC: \*ABANDONED\* 4-inch steel natural gas main through the levee, 2.5 feet below the crown. Vent on the waterside (WS) shoulder. Pipeline was abandoned, cut, and capped at the north end of the Rio Linda Blvd bridge. In case of an emergency related to this pipeline, PG&E has identified the following contacts: PG&E's local pipeline engineer, Mike Aronoff at 916-307-9472 (cell), and Gas Control (north) at 800-442-4743. For non-emergency issues, please contact the local PG&E Gas Pipeline Operations and Maintenance (GPOM) supervisors for the Sacramento region, David Wade at 209-639-1039 (cell), or Ron Hicks at 916-396-9038 (cell). (4-inch line installed under Permit No. 15152, 1989 - Pacific Gas and Electric Company [PG&E]; 4-inch will be raised above the 200-year water surface elevation within the levee crown under Permit No. 15152-1, 2016 - PG&E).

View of WS.

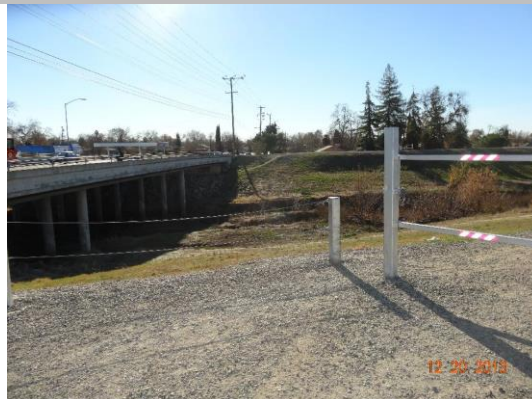
Photo 2 of 3 : UCIP\_SP\_2020\_53491\_75854.jpg

No signs of crossing visible through levee or channel.

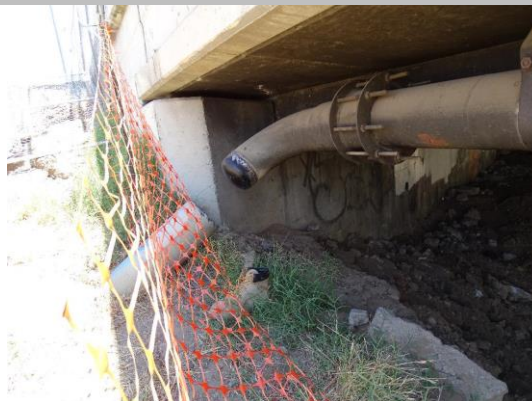
Photo 3 of 3 : UCIP\_SP\_2020\_53491\_77630.jpg

Natural gas pipeline grouted and capped on the WS at N end of Rio Linda Blvd bridge.

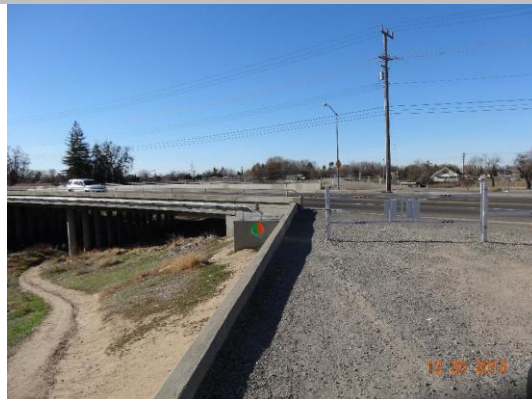
Photo 1 of 3 : UCIP\_SP\_2020\_29301\_54278.jpg

Comment Code						
Inspector Comment						
DS_ID:24370 FS_ID:29301 EP_NO: N/A Repair Type: No Action Needed Crossing Status: Found UCIP Comments: 08/16/2017 DWR Deferred Maintenance Project (DMP), Vince Rodriguez, forwarded email received from Tim Kerr, General Manager of American River Flood Control District (ARFCD) with file "DWR Eligible Pipes Found in ARFCD" from ARFCD that shows the ownership and location of the pipes Tim Kerr investigated. Owner of this crossing is identified as the City of Sacramento, ARFCD Staff Notes indicate Arcade CK just upstream of Rio Linda. (DWR UCIP - O. Magana) FIELD_STRUCT_DESC: 24-inch corrugated metal (CM) drainage pipe through the levee, 11 feet below the crown. Slide gate in CM riser on the waterside (WS) slope. Flap gate on the WS end. Concrete headwalls on both ends, WS and landside (LS). (no permit has been identified authorizing this structure, structure is owned by the City of Sacramento) [Additional Reference(s): DWR Levee Log, 2002. USACE Sacramento O&M Manual Unit 118, Part No. 2, October 1959, Drawing No. 1-4-392 Exhibit B, (Station 65+73)] FS Date: 12/20/2013

View of flood wall along waterward side.

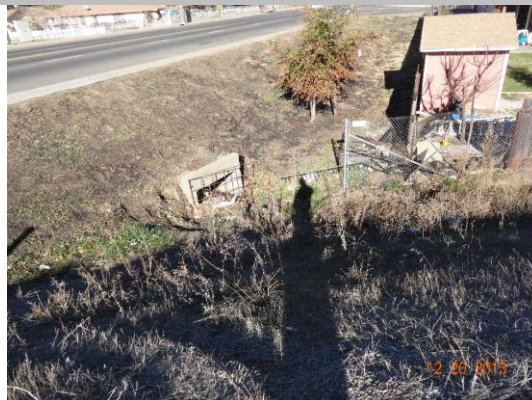
Photo 2 of 3 : UCIP\_SP\_2020\_29301\_54277.jpg

View of landward side.

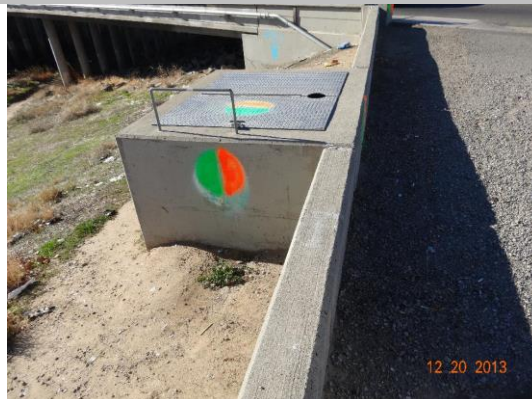
Photo 3 of 3 : UCIP\_SP\_2020\_29301\_54276.jpg

LM Start	1.33	Rating **	A/W	Issue No.	63 (cont)	
LM End	1.33	Issue Type +	Ma	Location *		
Category	Supplemental			GPS Latitude/Longitude		
				Start		End
Item	DWR UCIP LMA Responsibility			38.626321 °	38.626321 °	
				-121.445964 °	-121.445964 °	
DWR ID	24370

Concrete vault located on waterward shoulder.

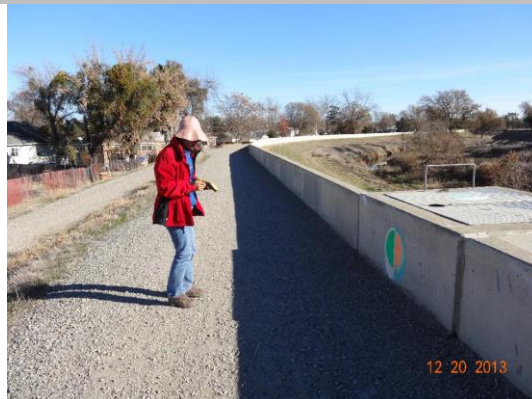
Photo 1 of 3 : UCIP\_SP\_2020\_29302\_54282.jpg

FIELD\_STRUCT\_DESC: 24-inch reinforced concrete drainage pipe through the levee, 9.3 feet below the crown. Concrete headwalls on both waterside (WS) and landside (LS) ends. Slide gate inside CM riser located on the WS slope. Flap gate is located on the WS end. (24-inch referenced in USACE O&M manual -- no permit found, the City of Sacramento is the owner; according to permit records for 12886 "old pipe removed. Concrete pipe in placed and backfilled part of it". Conflicting information makes it difficult to determine fate of 24-inch pipe (extent of work completed under permit); 30-inch pipe and removal of old pipe was authorized under Permit No. 12886, 1980 - City of Sacramento. To remove and replace an existing 24-inch reinforced concrete pipe authorized by Permit No. 19129, 2017 - City of Sacramento, Department of Utilities). [Additional Reference(s): DWR Levee Log, 2002. USACE Sacramento O&M Manual Unit 118, Part No. 2, October 1959, Drawing No. 1-4-392 Exhibit B, (Station 70+09)]. FS Date: 12/20/2013

View of levee crown--flood wall located along waterward shoulder.

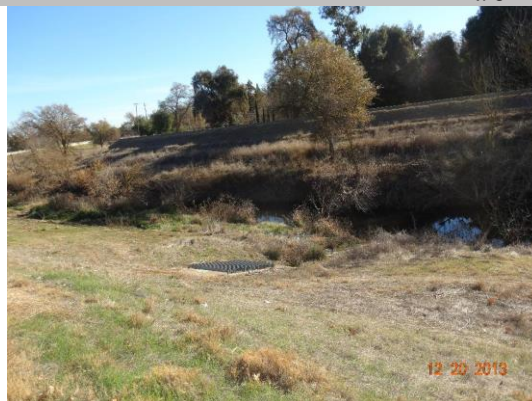
Photo 2 of 3 : UCIP\_SP\_2020\_29302\_54283.jpg

LM Start	<b>1.47</b>	Rating **	A/W	Issue No.	<b>64 (cont)</b>
LM End	<b>1.47</b>	Issue Type +	Ma	Location *	
Category	Supplemental		GPS Latitude/Longitude		
			Start	End	
Item	DWR UCIP LMA Responsibility		38.627201 °	38.627201 °	
			-121.443790 °	-121.443790 °	
DWR ID	24371

Headwall with debris screen located at waterward toe.

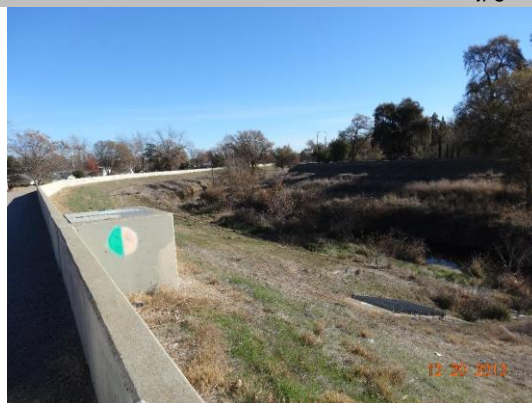
Photo 3 of 3 : UCIP\_SP\_2020\_29302\_54284.jpg

View of waterward side--concrete vault and headwall.

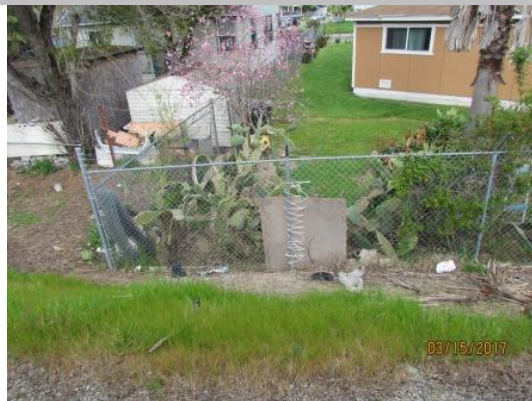
Photo 1 of 1 : SP\_2020\_NA0001\_58\_8\_20200302\_00006.jpg

LM Start	1.50	Rating **	M	Issue No.	8
LM End	1.50	Issue Type +	En	Location *	LS
Category	Earthen Levee			GPS Latitude/Longitude	
				Start	End
Item	Encroachments			38.627526 °	38.627526 °
				-121.443310 °	-121.443310 °
DWR ID	DWR_NA0001_07_s_2013_8				
Comment Code					
FE : Fence					
Inspector Comment					
Vegetation growing on the fence is blocking visibility.

View of the fence obstructing visibility and access at the landside levee toe. Spring 2017.

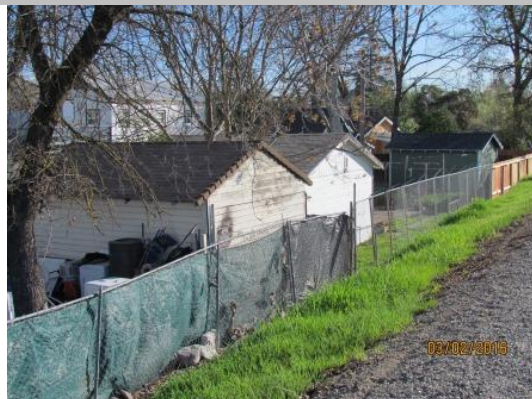
Photo 1 of 1 : SP\_2020\_NA0001\_58\_30\_20200302\_00024.jpg

LM Start	1.55	Rating **	U	Issue No.	30
LM End	1.55	Issue Type +	En	Location *	LS
Category	Earthen Levee			GPS Latitude/Longitude	
				Start	End
Item	Encroachments			38.627743 °	38.627743 °
				-121.442526 °	-121.442526 °
DWR ID	DWR_NA0001_07_s_2012_30				
Comment Code					
BU : Building					
Inspector Comment					
A large side building is within 10-ft of the levee toe.

View of the building at the landside levee toe. Spring 2016

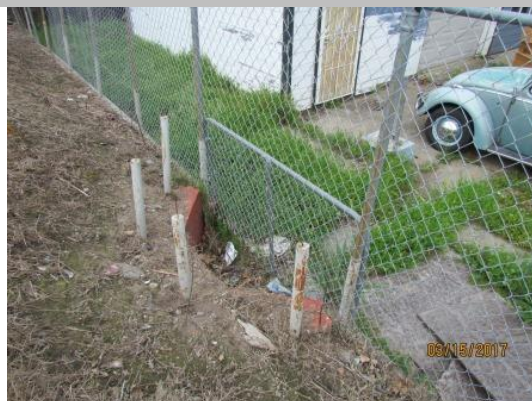
Photo 1 of 1 : SP\_2020\_NA0001\_58\_39\_20200302\_00027.jpg

LM Start	1.56	Rating **	M	Issue No.	39
LM End	1.56	Issue Type +	En	Location *	LS
Category	Earthen Levee			GPS Latitude/Longitude	
				Start	End
Item	Encroachments			38.627764 °	38.627764 °
				-121.442317 °	-121.442317 °
DWR ID	DWR_NA0001_07_s_2017_39				
Comment Code					
RW : Retaining Wall					
Inspector Comment					
A 4' retaining wall is on the levee toe.

View of the retaining wall into the levee prism. Spring 2017

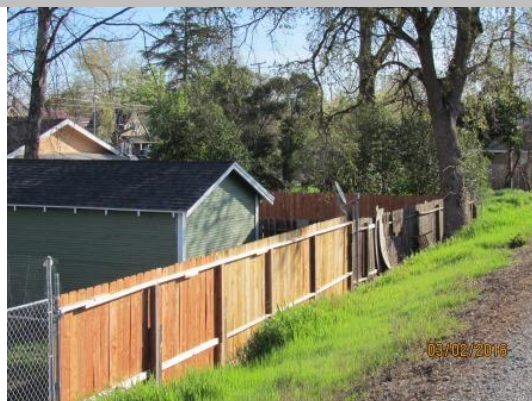
Photo 1 of 1 : SP\_2020\_NA0001\_58\_3\_20200302\_00002.jpg

LM Start	1.57	Rating **	U	Issue No.	3
LM End	1.57	Issue Type +	En	Location *	LS
Category	Earthen Levee			GPS Latitude/Longitude	
				Start	End
Item	Encroachments			38.627768 °	38.627768 °
				-121.442185 °	-121.442185 °
DWR ID	DWR_NA0001_07_s_2012_3				
Comment Code					
FE : Fence					
Inspector Comment					
A wooden privacy fence is within 10-ft of the levee toe.

Wooden privacy fence is constructed at the landside levee toe. Spring 2016

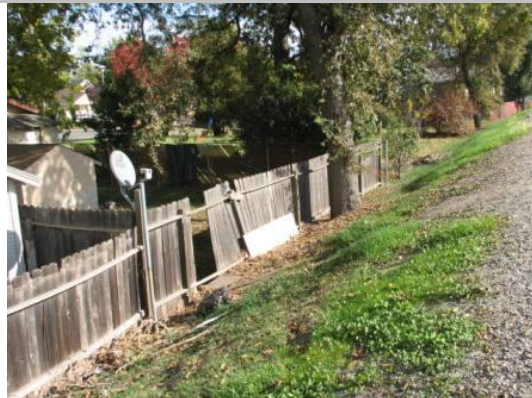
Photo 1 of 1 : SP\_2020\_NA0001\_58\_4\_20200302\_00003.jpg

LM Start	1.58	Rating **	U	Issue No.	4
LM End	1.58	Issue Type +	En	Location *	LS
Category	Earthen Levee			GPS Latitude/Longitude	
				Start	End
Item	Encroachments			38.627707 °	38.627707 °
				-121.441965 °	-121.441965 °
DWR ID	DWR_NA0001_07_s_2012_4				
Comment Code					
FE : Fence					
Inspector Comment					
A wooden privacy fence is within 10-ft of the levee toe.

11/17/2011 Wooden privacy fence is constructed at the toe.

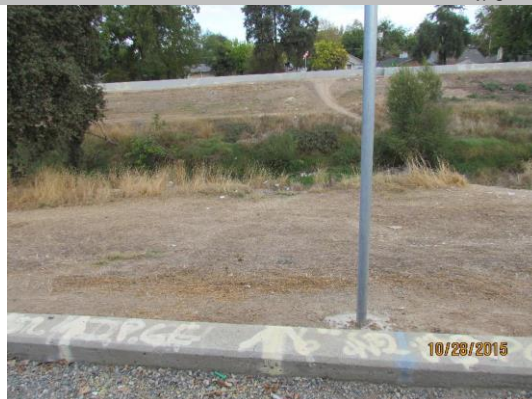
Photo 1 of 3 : UCIP\_SP\_2020\_52672\_74733.jpg

LM Start	1.60	Rating **	M	Issue No.	65	
LM End	1.60	Issue Type +	En	Location *		
Category	Supplemental			GPS Latitude/Longitude		
				Start	End	
Item	DWR UCIP Field Study			38.627760 °	38.627760 °	
				-121.441593 °	-121.441593 °	
DWR ID	24835

Comment Code						
Inspector Comment						
DS_ID:24835						
FS_ID:52672						
EP_NO: N/A						
Repair Type: Non-Urgent						
Crossing Status: Indicator Found						
UCIP Comments: 08/11/2017 PG&E records for DFM 0614-13 indicate that there were no observations found on the 07/2017 patrol, no leaks found on the 04/2017 leak survey, and the pipeline is operating correctly according to the 11/2016 CP inspection. (DWR UCIP - A. McDonald)11/12/15 Markers have been installed on both levees--confirmed during 2015 DWR Fall Inspection. Need to coordinate with PG&E to determine permit for this crossing.12/19/13 Gas line - no markers visible. No permit available.						
FIELD_STRUCT_DESC: 2 of 2: 6-inch gasoline of unknown material through the levee and under the channel at an unknown depth. In case of an emergency related to this pipeline, PG&E has identified the following contacts: PG&E's local pipeline engineer, Mike Aronoff at 916-307-9472 (cell), and Gas Control (north) at 800-442-4743. For non-emergency issues, please contact the local PG&E Gas Pipeline Operations and Maintenance (GPOM) supervisors for the Sacramento region, David Wade at 209-639-1039 (cell), or Ron Hicks at 916-396-9038 (cell).

Markers installed through both levees in 2015.

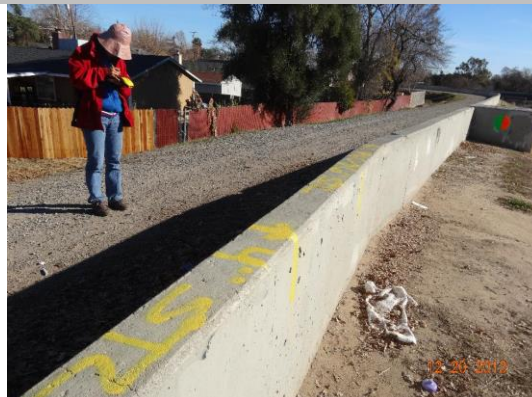
Photo 2 of 3 : UCIP\_SP\_2020\_52672\_57525.jpg

LM Start	<b>1.60</b>	Rating **	M	Issue No.	<b>65 (cont)</b>
LM End	<b>1.60</b>	Issue Type +	En	Location *	
Category	Supplemental		GPS Latitude/Longitude		
			Start	End	
Item	DWR UCIP Field Study		38.627760 °	38.627760 °	
			-121.441593 °	-121.441593 °	
DWR ID	24835

Underground service alert (USA) markings visible on floodwall.

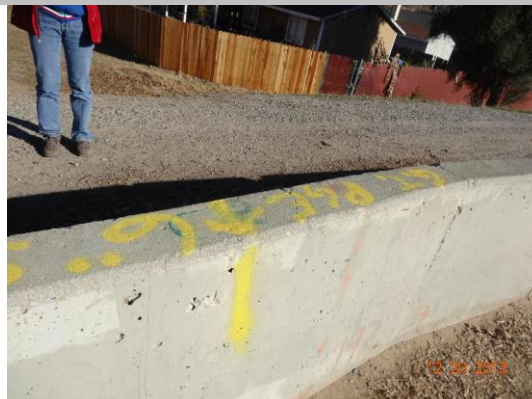
Photo 3 of 3 : UCIP\_SP\_2020\_52672\_57524.jpg

6-inch gas line through levee at an unknown depth.

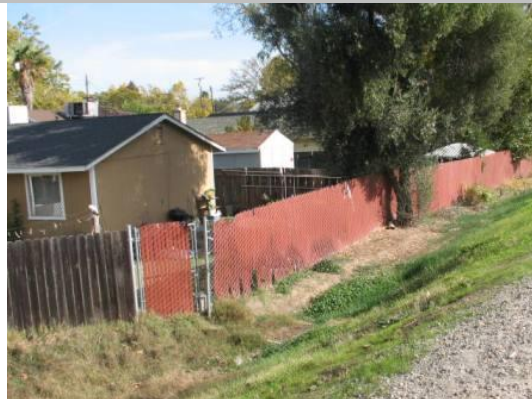
Photo 1 of 1 : SP\_2020\_NA0001\_58\_29\_20200302\_00023.jpg

LM Start	1.61	Rating **	M	Issue No.	29
LM End	1.61	Issue Type +	En	Location *	LS
Category	Earthen Levee			GPS Latitude/Longitude	
				Start	End
Item	Encroachments			38.627733 °	38.627733 °
				-121.441415 °	-121.441415 °
DWR ID	DWR_NA0001_07_s_2012_29				
Comment Code					
FE : Fence					
Inspector Comment					
A fence is within 10-ft of the levee toe.

11/17/2011 Privacy fence is constructed at the toe.

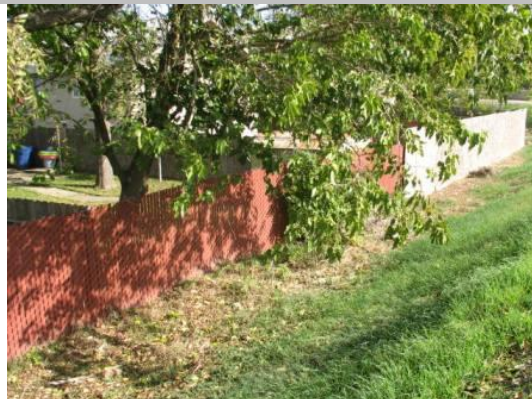
Photo 1 of 1 : SP\_2020\_NA0001\_58\_27\_20200302\_00021.jpg

LM Start	1.63	Rating **	U	Issue No.	27
LM End	1.63	Issue Type +	En	Location *	LS
Category	Earthen Levee			GPS Latitude/Longitude	
				Start	End
Item	Encroachments			38.627681 °	38.627681 °
				-121.441021 °	-121.441021 °
DWR ID	DWR_NA0001_07_s_2012_27				
Comment Code					
FE : Fence					
Inspector Comment					
A fence and overgrown trees are within 10-ft of the levee toe.

11/17/2011 Privacy fence is constructed at the toe.

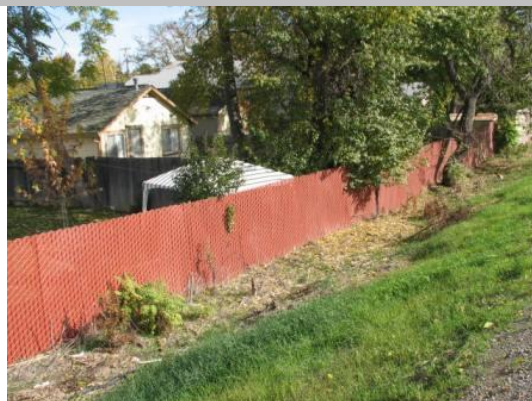
Photo 1 of 1 : SP\_2020\_NA0001\_58\_28\_20200302\_00022.jpg

LM Start	1.63	Rating **	M	Issue No.	28
LM End	1.63	Issue Type +	En	Location *	LS
Category	Earthen Levee			GPS Latitude/Longitude	
				Start	End
Item	Encroachments			38.627668 °	38.627668 °
				-121.441018 °	-121.441018 °
DWR ID	DWR_NA0001_07_s_2012_28				
Comment Code					
FE : Fence					
Inspector Comment					
A fence is within 10-ft of the levee toe.

11/17/2011 Privacy fence is constructed at the toe.

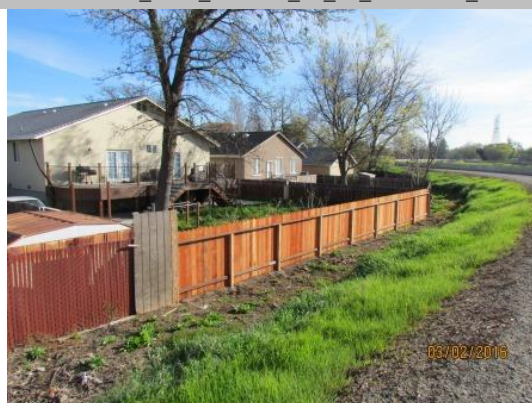
Photo 1 of 1 : SP\_2020\_NA0001\_58\_26\_20200302\_00020.jpg

LM Start	1.64	Rating **	U	Issue No.	26
LM End	1.64	Issue Type +	En	Location *	LS
Category	Earthen Levee			GPS Latitude/Longitude	
				Start	End
Item	Encroachments			38.627667 °	38.627667 °
				-121.440837 °	-121.440837 °
DWR ID	DWR_NA0001_07_s_2012_26				
Comment Code					
FE : Fence					
Inspector Comment					
A wooden privacy fence is within 10-ft of the levee toe.

View of the wooden fence at the landside levee toe. Spring 2016

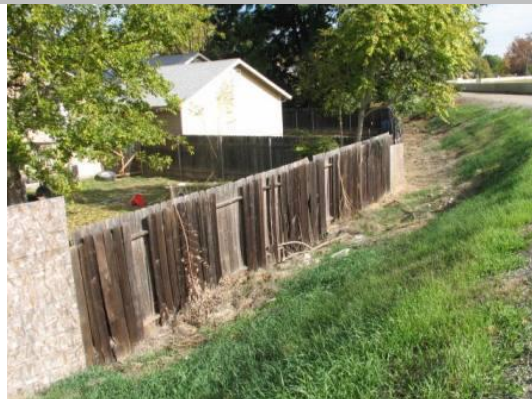
Photo 1 of 1 : SP\_2020\_NA0001\_58\_25\_20200302\_00019.jpg

LM Start	1.65	Rating **	U	Issue No.	25
LM End	1.65	Issue Type +	En	Location *	LS
Category	Earthen Levee			GPS Latitude/Longitude	
				Start	End
Item	Encroachments			38.627677 °	38.627677 °
				-121.440629 °	-121.440629 °
DWR ID	DWR_NA0001_07_s_2012_25				
Comment Code					
FE : Fence					
Inspector Comment					
A wooden privacy fence is within 10-ft of the levee toe.

11/17/2011 Wooden privacy fence is constructed at the toe.

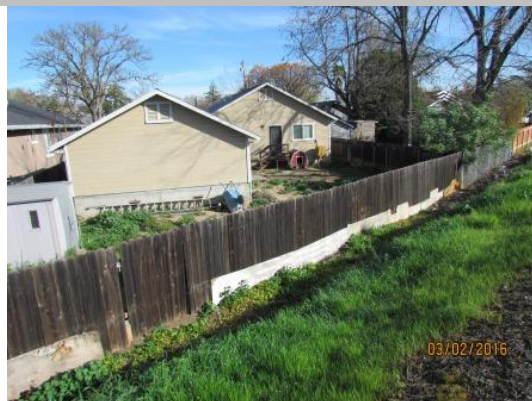
Photo 1 of 1 : SP\_2020\_NA0001\_58\_40\_20200302\_00028.jpg

LM Start	1.66	Rating **	U	Issue No.	40
LM End	1.66	Issue Type +	En	Location *	LS
Category	Earthen Levee			GPS Latitude/Longitude	
				Start	End
Item	Encroachments			38.627727 °	38.627727 °
				-121.440442 °	-121.440442 °
DWR ID	DWR_NA0001_07_s_2016_40				
Comment Code					
FE : Fence					
Inspector Comment

View of the fence at the landside levee toe. Spring 2016

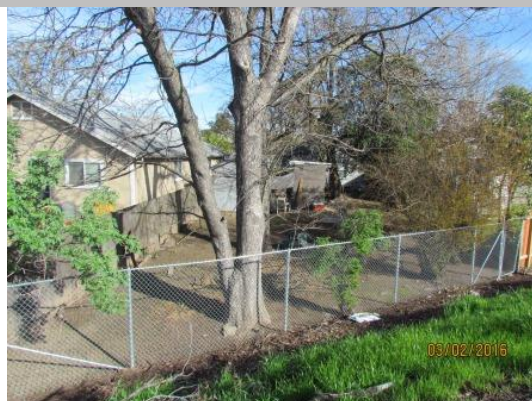
Photo 1 of 1 : SP\_2020\_NA0001\_58\_41\_20200302\_00029.jpg

LM Start	1.67	Rating **	M	Issue No.	41
LM End	1.67	Issue Type +	En	Location *	LS
Category	Earthen Levee			GPS Latitude/Longitude	
				Start	End
Item	Encroachments			38.627803 °	38.627803 °
				-121.440270 °	-121.440270 °
DWR ID	DWR_NA0001_07_s_2016_41				
Comment Code					
FE : Fence					
Inspector Comment

View of the fence at the landside levee toe. Spring 2016

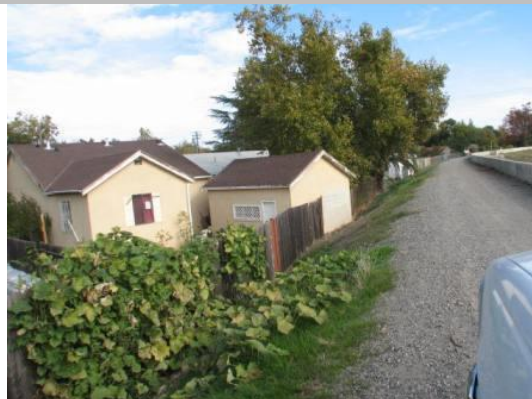
Photo 1 of 1 : SP\_2020\_NA0001\_58\_7\_20200302\_00005.jpg

LM Start	1.70	Rating **	U	Issue No.	7
LM End	1.70	Issue Type +	En	Location *	LS
Category	Earthen Levee			GPS Latitude/Longitude	
				Start	End
Item	Encroachments			38.627935 °	38.627935 °
				-121.439758 °	-121.439758 °
DWR ID	DWR_NA0001_07_s_2012_7				
Comment Code					
BU : Building					
Inspector Comment					
The corner of the building protrudes into the levee slope. The wooden fence is built on the levee slope.

11/17/2011 Building is constructed at the toe.

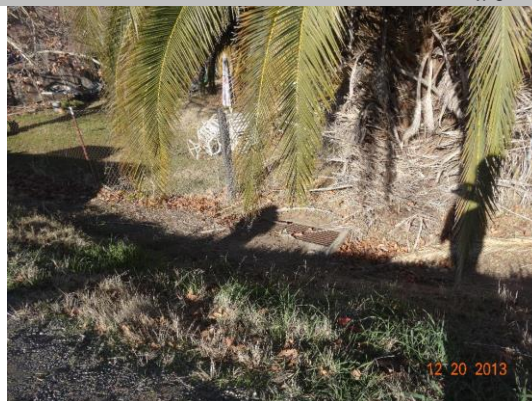
Photo 1 of 3 : UCIP\_SP\_2020\_29324\_54305.jpg

Comment Code						
Inspector Comment						
DS_ID:24373 FS_ID:29324 EP_NO: N/A Repair Type: No Action Needed Crossing Status: Found UCIP Comments: 08/16/2017 DWR Deferred Maintenance Project (DMP), Vince Rodriguez, forwarded email received from Tim Kerr, General Manager of American River Flood Control District (ARFCD) with file "DWR Eligible Pipes Found in ARFCD" from ARFCD that shows the ownership and location of the pipes Tim Kerr investigated. Owner of this crossing is identified as the City of Sacramento, ARFCD Staff Notes indicate Arcade Ck. (DWR UCIP - O. Magana) 06/14/2017 This crossing is scheduled to be cut and replaced as part of Sacramento Area Flood Control (SAFCA) North Area Streams (NAS) Levee Improvement Project: City of Sacramento Utility Permit Modifications Along Arcade Creek Levees. Unable to confirm when pipe will be replaced. Need to coordinate with owner and DWR FPIIB Inspector to determine when project is expected to start. (DWR UCIP - O. Magana). FIELD_STRUCT_DESC: 24-inch reinforced concrete drainage pipe through the levee, 7.8 feet below the crown. Concrete headwall on each end. Slide gate inside a corrugated metal (CM) riser on the waterside (WS) slope. Flap gate at the outlet. (No permit has been identified authorizing this structure. Structure is owned by the City of Sacramento. To remove and replace an existing 24-inch reinforced concrete pipe authorized by Permit No. 19126, 2017 - City of Sacramento, Department of Utilities). [Additional Reference(s): DWR Levee Log, 2002. USACE Sacramento O&M Manual Unit 118, Part No. 2, October 1959, Drawing No. 1-4-392 Exhibit B, (Station 77+12)]. FS Date: 12/20/2013

View of landward side.

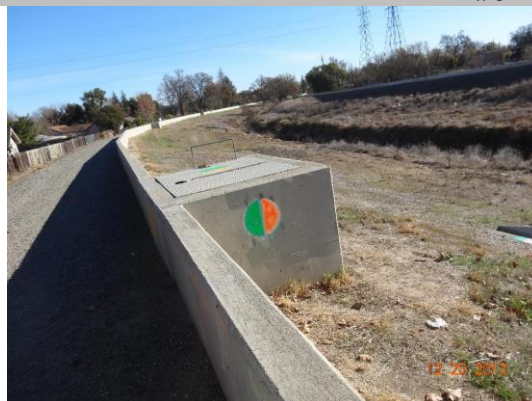
Photo 2 of 3 : UCIP\_SP\_2020\_29324\_54307.jpg

LM Start	<b>1.72</b>	Rating **	A/W	Issue No.	<b>66 (cont)</b>
LM End	<b>1.72</b>	Issue Type +	Ma	Location *	
Category	Supplemental		GPS Latitude/Longitude		
			Start	End	
Item	DWR UCIP LMA Responsibility		38.628108 °	38.628108 °	
			-121.439471 °	-121.439471 °	
DWR ID	24373

Floodwall along waterward shoulder.

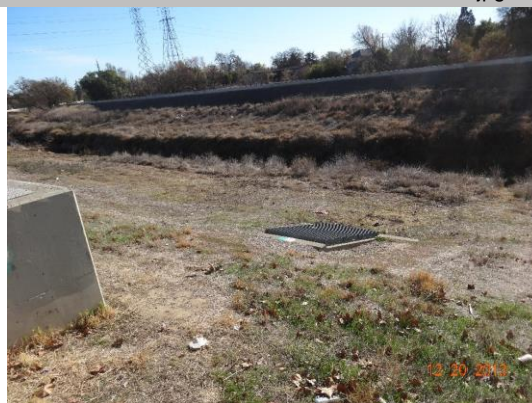
Photo 3 of 3 : UCIP\_SP\_2020\_29324\_54306.jpg

Concrete headwall with debris screen located on waterward toe.

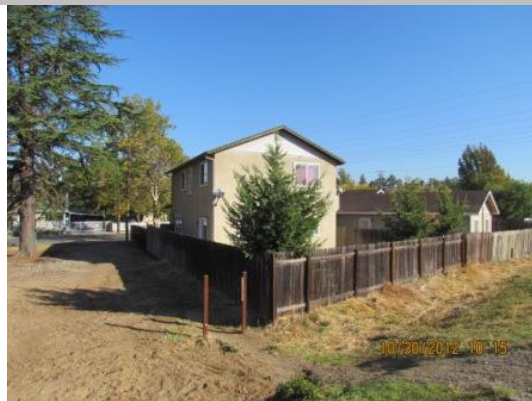
Photo 1 of 1 : SP\_2020\_NA0001\_58\_23\_20200302\_00018.jpg

LM Start	1.74	Rating **	U	Issue No.	23
LM End	1.74	Issue Type +	En	Location *	LS
Category	Earthen Levee			GPS Latitude/Longitude	
				Start	End
Item	Encroachments			38.628221 °	38.628221 °
				-121.439138 °	-121.439138 °
DWR ID	DWR_NA0001_07_s_2012_23				
Comment Code					
FE : Fence					
Inspector Comment					
The wooden fence and cedar trees are within 10-ft of the levee toe.

View of wooden privacy fence constructed at the toe.

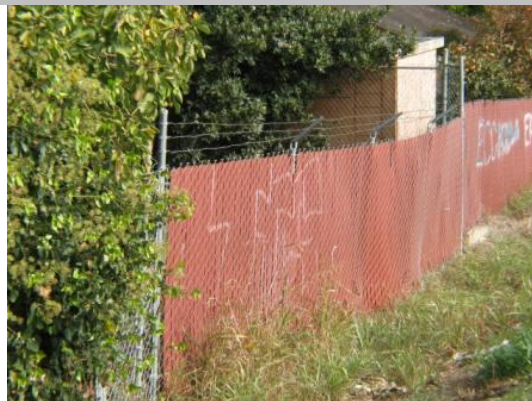
Photo 1 of 1 : SP\_2020\_NA0001\_58\_12\_20200302\_00010.jpg

LM Start	1.81	Rating **	U	Issue No.	12
LM End	1.81	Issue Type +	En	Location *	LS
Category	Earthen Levee			GPS Latitude/Longitude	
				Start	End
Item	Encroachments			38.628307 °	38.628307 °
				-121.437842 °	-121.437842 °
DWR ID	DWR_NA0001_07_s_2012_12				
Comment Code					
FE : Fence					
Inspector Comment					
A chain link privacy fence with barbed wire is within 10-ft of levee toe.

11/17/2011 Barbed wire fence is located at the toe.

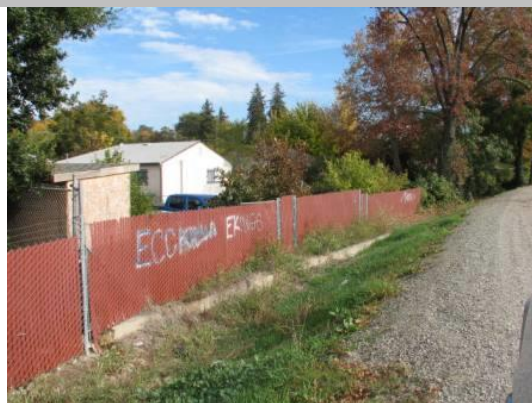
Photo 1 of 1 : SP\_2020\_NA0001\_58\_13\_20200302\_00011.jpg

LM Start	1.82	Rating **	U	Issue No.	13
LM End	1.82	Issue Type +	En	Location *	LS
Category	Earthen Levee			GPS Latitude/Longitude	
				Start	End
Item	Encroachments			38.628303 °	38.628303 °
				-121.437693 °	-121.437693 °
DWR ID	DWR_NA0001_07_s_2012_13				
Comment Code					
FE : Fence					
Inspector Comment					
A chain link privacy fence is within 10-ft of levee toe.

11/17/2011 Privacy fence is located at the toe.

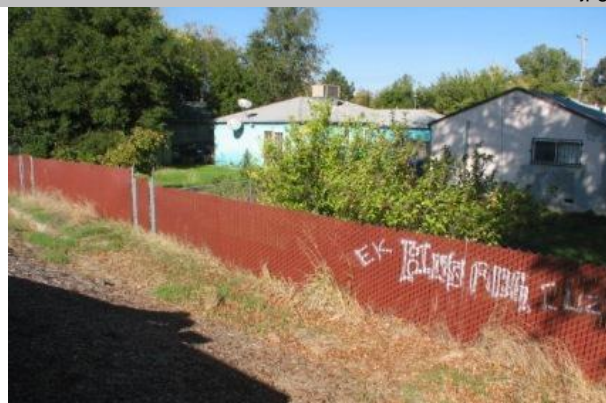
Photo 1 of 1 : SP\_2020\_NA0001\_58\_14\_20200302\_00012.jpg

LM Start	1.83	Rating **	U	Issue No.	14
LM End	1.83	Issue Type +	En	Location *	LS
Category	Earthen Levee			GPS Latitude/Longitude	
				Start	End
Item	Encroachments			38.628303 °	38.628303 °
				-121.437530 °	-121.437530 °
DWR ID	DWR_NA0001_07_s_2012_14				
Comment Code					
FE : Fence					
Inspector Comment					
A chain link privacy fence is within 10-ft of levee toe.

Fall 2009 photo of privacy fence within 10-ft of the levee toe obstructs visibility and access.

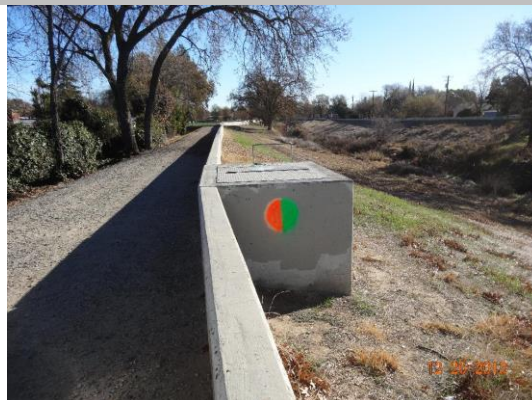
Photo 1 of 3 : UCIP\_SP\_2020\_29326\_54319.jpg

DS\_ID:24375  
FS\_ID:29326  
EP\_NO: N/A  
Repair Type: No Action Needed  
Crossing Status: Found  
UCIP Comments: 08/16/2017 DWR Deferred Maintenance Project (DMP), Vince Rodriguez, forwarded email received from Tim Kerr, General Manager of American River Flood Control District (ARFCD) with file "DWR Eligible Pipes Found in ARFCD" from ARFCD that shows the ownership and location of the pipes Tim Kerr investigated. Owner of this crossing is identified as the City of Sacramento, ARFCD Staff Notes indicate Arcade Ck. (DWR UCIP - O. Magana)  
06/14/2017 This crossing is scheduled to be cut and replaced as part of Sacramento Area Flood Control (SAFCA) North Area Streams (NAS) Levee Improvement Project: City of Sacramento Utility Permit Modifications Along Arcade Creek Levees. Unable to confirm when pipe will be replaced. Need to coordinate with owner and DWR FPIIB Inspector to determine when project is expected to start. (DWR UCIP - O. Magana).

FIELD\_STRUCT\_DESC: 24-inch reinforced concrete drainage pipe through the levee, 8.6 feet below the crown. Slide gate inside a corrugated metal (CM) riser unit on the waterside (WS) slope. Flap gate at the outlet. Concrete headwall on each end. (No permit has been identified authorizing the original structure. Structure is owned by the City of Sacramento. To remove and replace an existing 24-inch reinforced concrete pipe authorized by Permit No. 19127, 2017 - City of Sacramento, Department of Utilities). [Additional Reference(s): DWR Levee Log, 2002. USACE Sacramento O&M Manual Unit No. 118, Part No. 2, October 1959, Drawing No. 1-4-392, Exhibit B, (Station 84+62)].  
FS Date: 12/20/2013

Floodwall along waterward shoulder for almost entire Unit.

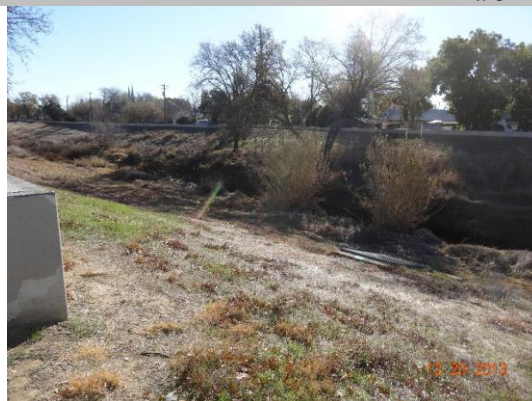
Photo 2 of 3 : UCIP\_SP\_2020\_29326\_54318.jpg

LM Start	<b>1.83</b>	Rating **	A/W	Issue No.	<b>67 (cont)</b>
LM End	<b>1.83</b>	Issue Type +	Ma	Location *	
Category	Supplemental		GPS Latitude/Longitude		
			Start	End	
Item	DWR UCIP LMA Responsibility		38.628381 °	38.628381 °	
			-121.437412 °	-121.437412 °	
DWR ID	24375

View of waterward slope.

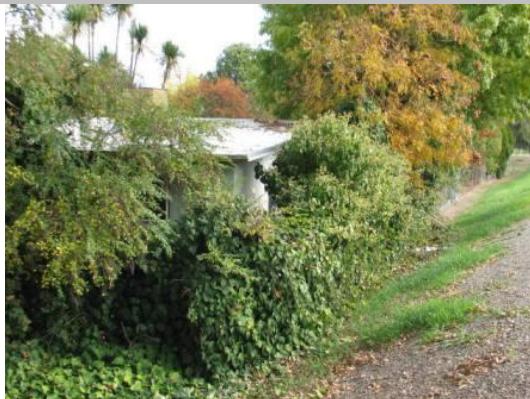
Photo 1 of 1 : SP\_2020\_NA0001\_58\_16\_20200302\_00015.jpg

LM Start	1.86	Rating **	U	Issue No.	16
LM End	1.86	Issue Type +	En	Location *	LS
Category	Earthen Levee			GPS Latitude/Longitude	
				Start	End
Item	Vegetation			38.628262 °	38.628262 °
				-121.436985 °	-121.436985 °
DWR ID	DWR_NA0001_07_s_2012_16				
Comment Code					
V6 : Landscaping					
Inspector Comment					
Dense ivy and trees along chain link fence are on the levee toe. A large building is within 10-ft of the levee toe.

11/17/2011 Vegetation and building obstruct visibility and access to the levee toe.

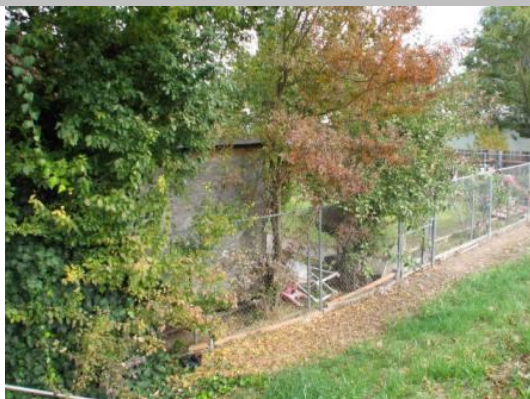
Photo 1 of 1 : SP\_2020\_NA0001\_58\_22\_20200302\_00017.jpg

LM Start	1.87	Rating **	U	Issue No.	22
LM End	1.87	Issue Type +	En	Location *	LS
Category	Earthen Levee			GPS Latitude/Longitude	
				Start	End
Item	Encroachments			38.628318 °	38.628318 °
				-121.436794 °	-121.436794 °
DWR ID	DWR_NA0001_07_s_2012_22				
Comment Code					
BU : Building					
Inspector Comment					
A wooden shed and landscaping along the chain link fence are within 10-ft of the levee toe.

11/17/2011 Building is too close to the levee toe and obstructs visibility and access.

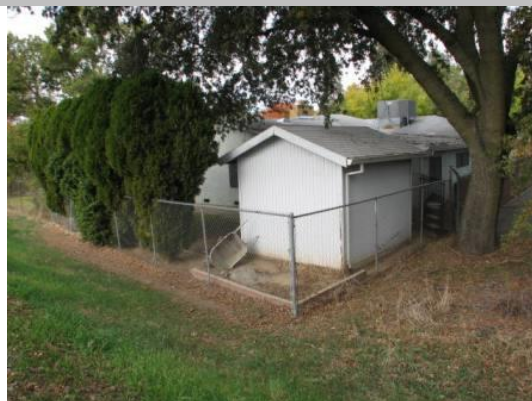
Photo 1 of 1 : SP\_2020\_NA0001\_58\_21\_20200302\_00016.jpg

LM Start	1.89	Rating **	U	Issue No.	21
LM End	1.89	Issue Type +	En	Location *	LS
Category	Earthen Levee			GPS Latitude/Longitude	
				Start	End
Item	Vegetation			38.628280 °	38.628280 °
				-121.436365 °	-121.436365 °
DWR ID	DWR_NA0001_07_s_2012_21				
Comment Code					
V6 : Landscaping					
Inspector Comment					
A wooden side building and juniper trees along chain link fence are within 10-ft of the landside toe.

11/17/2011 Building and landscaping near the levee toe.
